PROJECT NO. 1470472-1
SUBJECT: Operational Suitability Test of
the DR-37A Airway

HEADQUARTERS
AIR PROVING GROUND COMMAND
Eglin Air Force Base, Florida

INTERIM REPORT
ON THE
OPERATIONAL SUITABILITY TEST OF THE
RP-57A AIRCRAFT

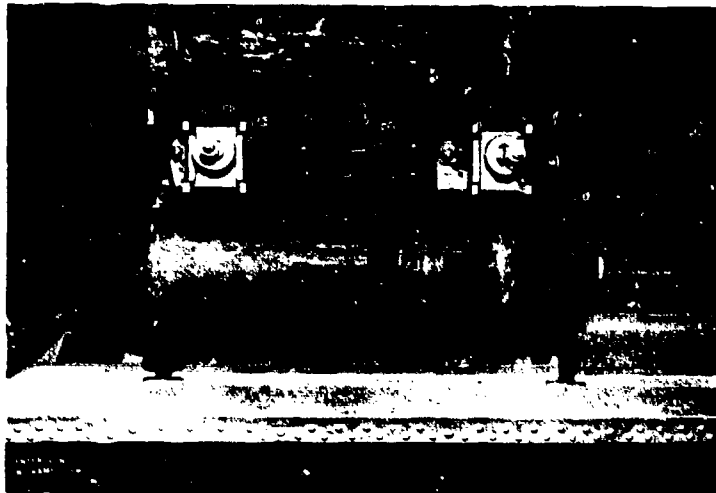
PHOTO 12

M30 GP Bomb (100 pound) installed in forward bay. Note position of forward bolt assembly. Distance between bolt assemblies does not allow installation of this bomb in forward bay. Also note that forward chock assembly does not rest all of its friction surface on bombs.

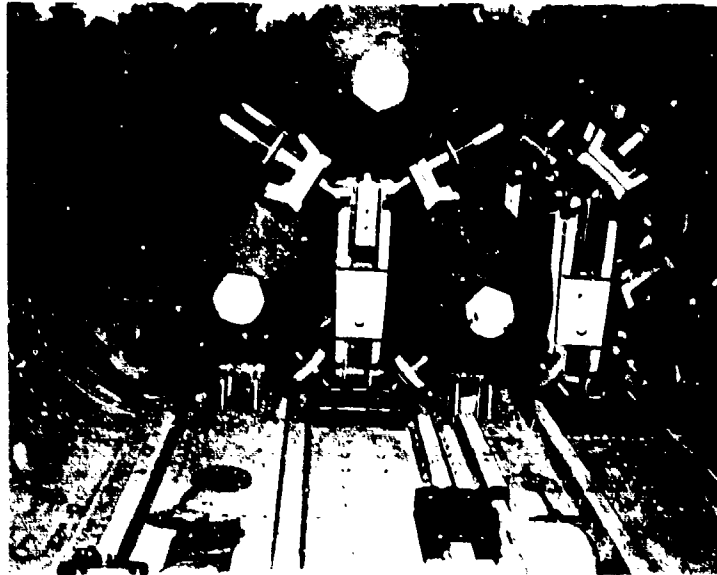
PHOTO 13

Front view of M30 GP Bomb in forward bay showing sway braces fully extended yet barely touching ogive of bomb.
